INTEGRATED STUDIES FOR THE EVALUATION OF CONSERVATION TREATMENTS ON BUILDING MATERIALS FROM ARCHAEOLOGICAL SITES. APPLICATION TO THE CASE OF MERIDA (SPAIN)

Keywords: NDT; Conservation; Treatments; Archaeological sites; Evaluation

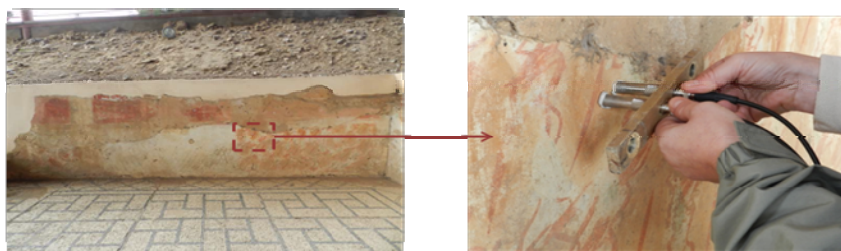
Treated area: 2182 m/s

Untreated area: 1611m/s

Fig. 4. UPV measurements on SDH13MA wall from Mitreo's House (Photo by Natalia Perez)

- UPV is especially useful when evaluating the efficacy of consolidative treatments [5, 6]. Measurements, in indirect mode, have been carried out on some wall paintings from Mitreo's House using transducers with a flat contact surface diameter of 12 mm and 1 MHz of energy. In the example showed in figure 4, comparative analysis results in a remarkable difference between treated (with Paraloid B72©) and untreated areas of the same panel. Values will allow us to assess the effectiveness of consolidative treatments applied in terms of higher strength of this area; nevertheless it should be correlated with other parameters, such as, for instance, chromatic measurements, in order to confirm a positive judgment.
